PV JOHN OXLEY RESTORATION

PROGRESS REPORT October 2019.

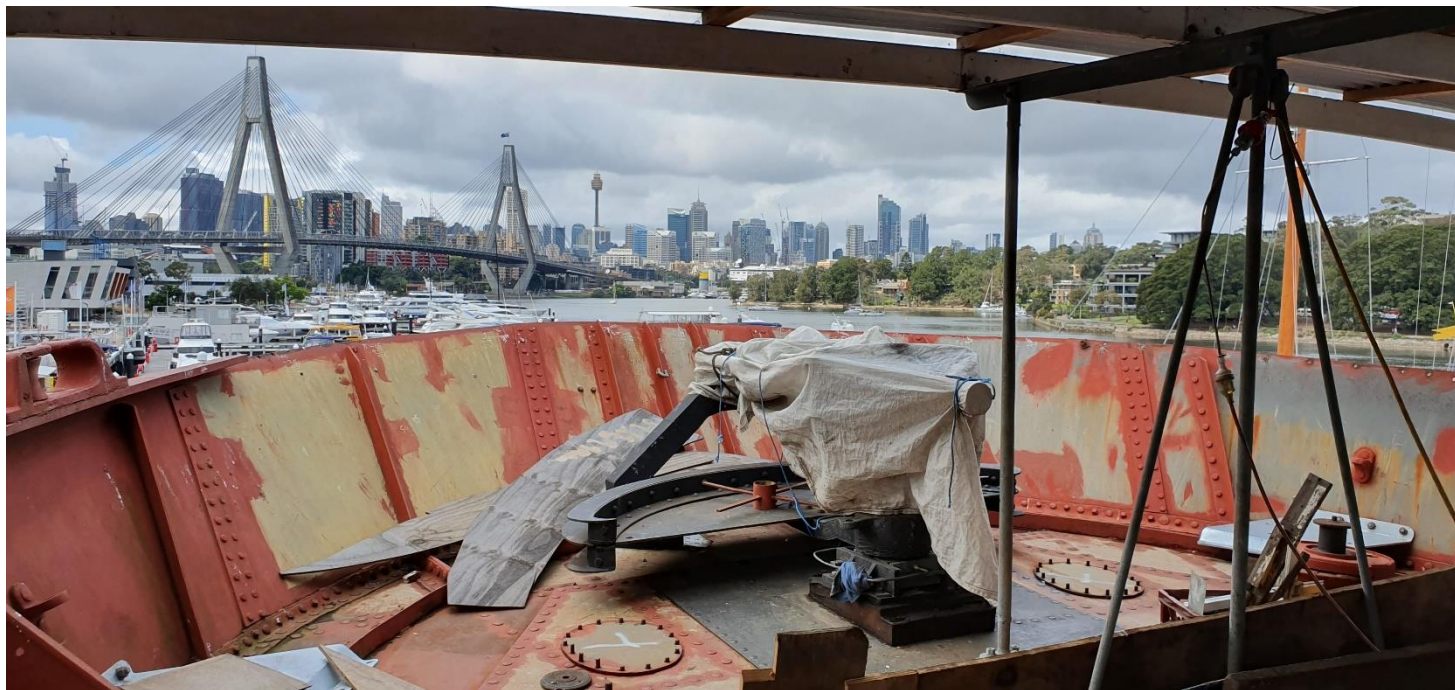
The continuation of the caprail seen on the left needs to be continued around the stern.

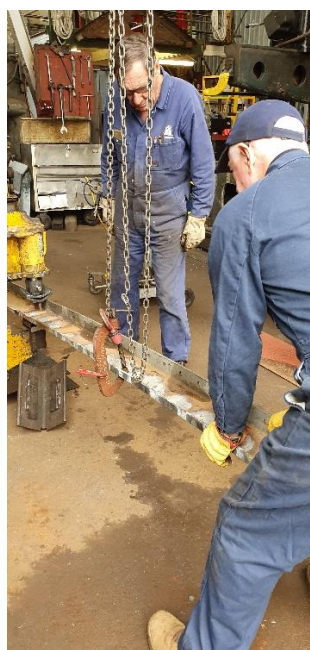
Steve & Bill working on the caprail.

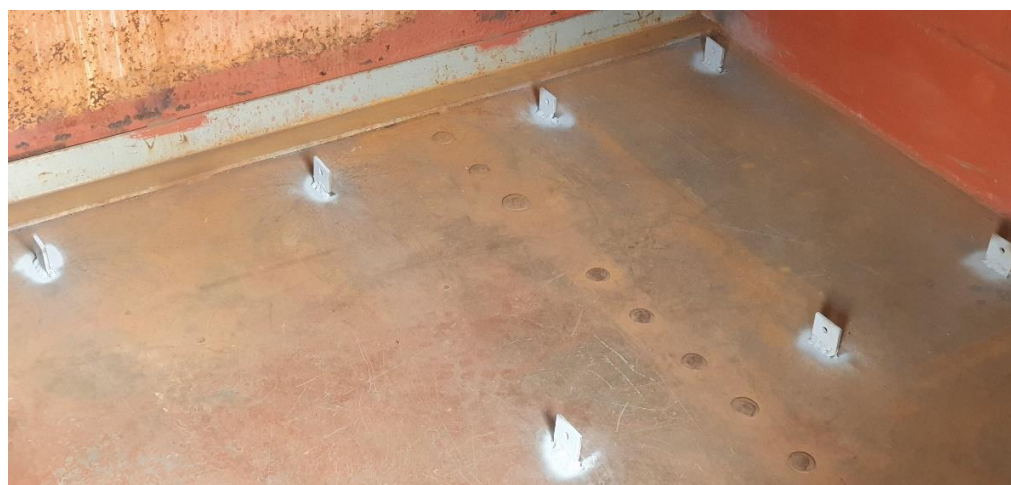
Second Engineers Cabin deck bearer lugs in position.

Second Engineers Cabin: The Bob Ellis team is moving on to the 2nd Engineers Cabin fit out and Pilots Bathroom and Head. Steel deck bearer lugs are in position in the engineers cabin ready for the team to start the fit out. Please view the pictures on page 2.

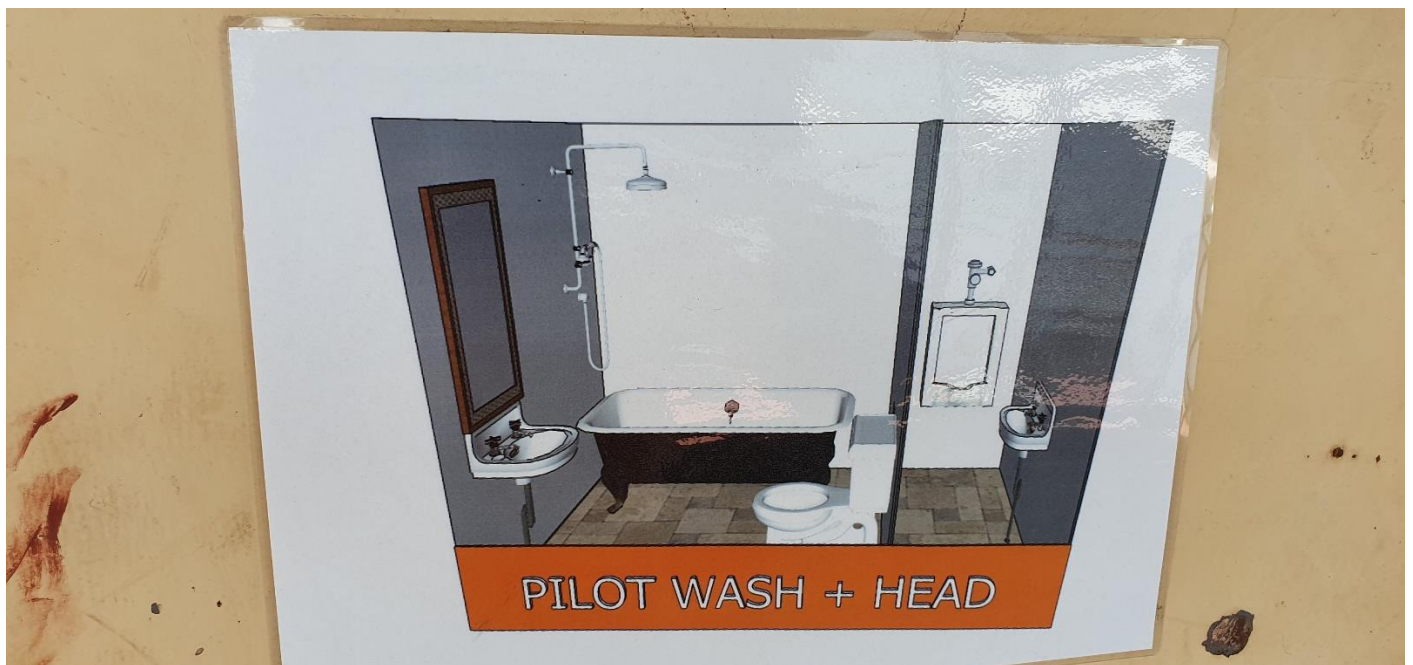
Cabin mock ups show how the Bob Ellis team are going to commence fitting out. Artwork courtesy Andy Munns.

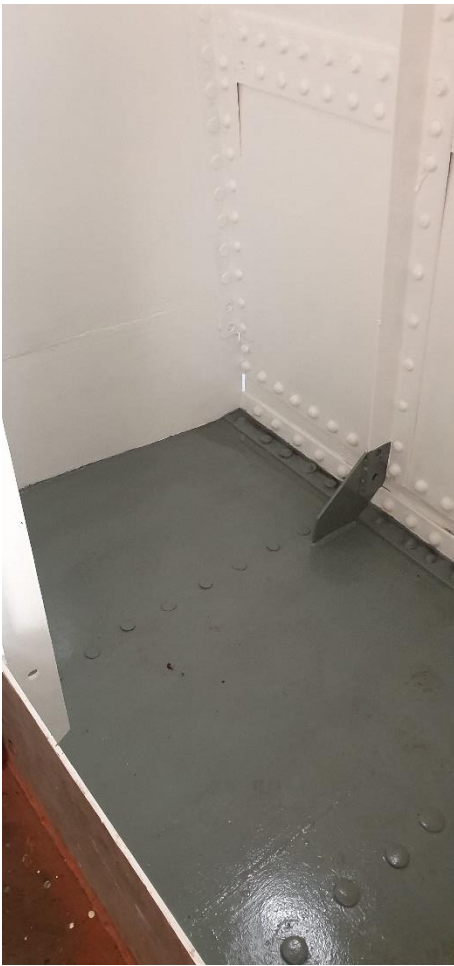
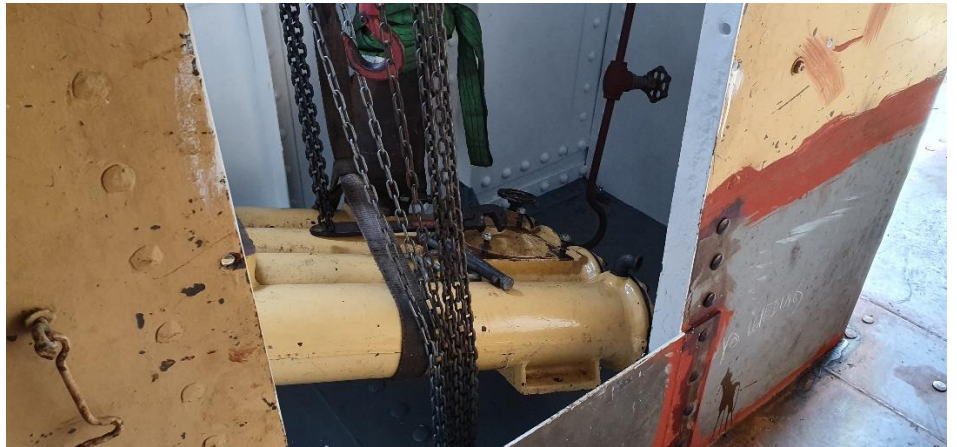
Freshly painted space for the Ammonia Fridge Unit and part of it being fitted in that space.

Engine Room: The ammonia Fridge Set of machinery was hoisted on board for mounting in its allocated space and painting. Pictures page 4 show the fridge set and also in its dismantled state partially in its space. Sandy our machinery painter extraordinaire will need to perform a Houdini act to paint it once assembled.

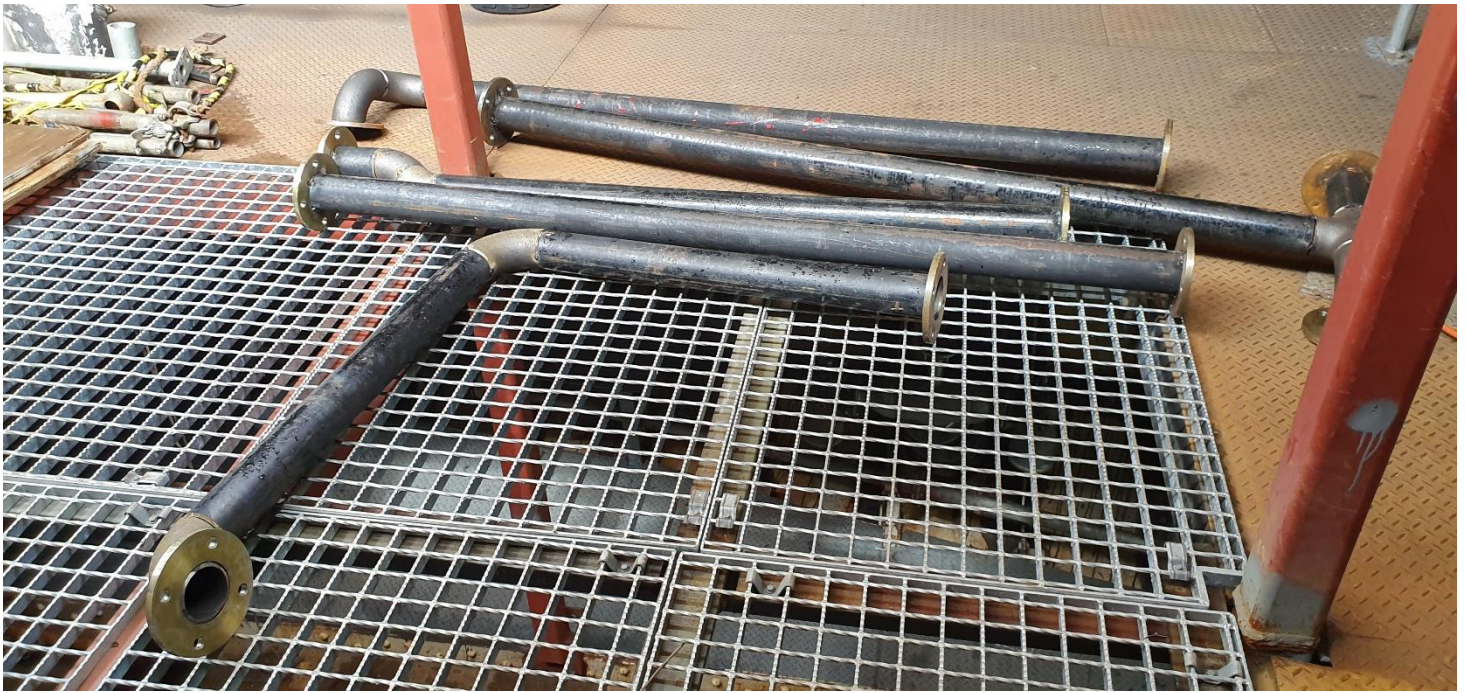
The pipes and the detail and patience required to complete the job. Please refer to page 1.

Fire Pump cooling pipes: Cutting and fitting of the cooling lines has commenced under the leadership of Ian Bird with Chris Ford assisting. Pictures will depict the detail and patience required to complete this type of work. As covered in a previous report, sections of the pipe are cut and temporally fitted and tack welded as the pictures on page 5 show then re fitted to check ok then taken down. Fully weld each joint, fitted again to ensure no undue expansion and finally removed and sent out for hot dip galvanising. Back again possibly painted then final fitting and bolting the flanges and pressure testing.

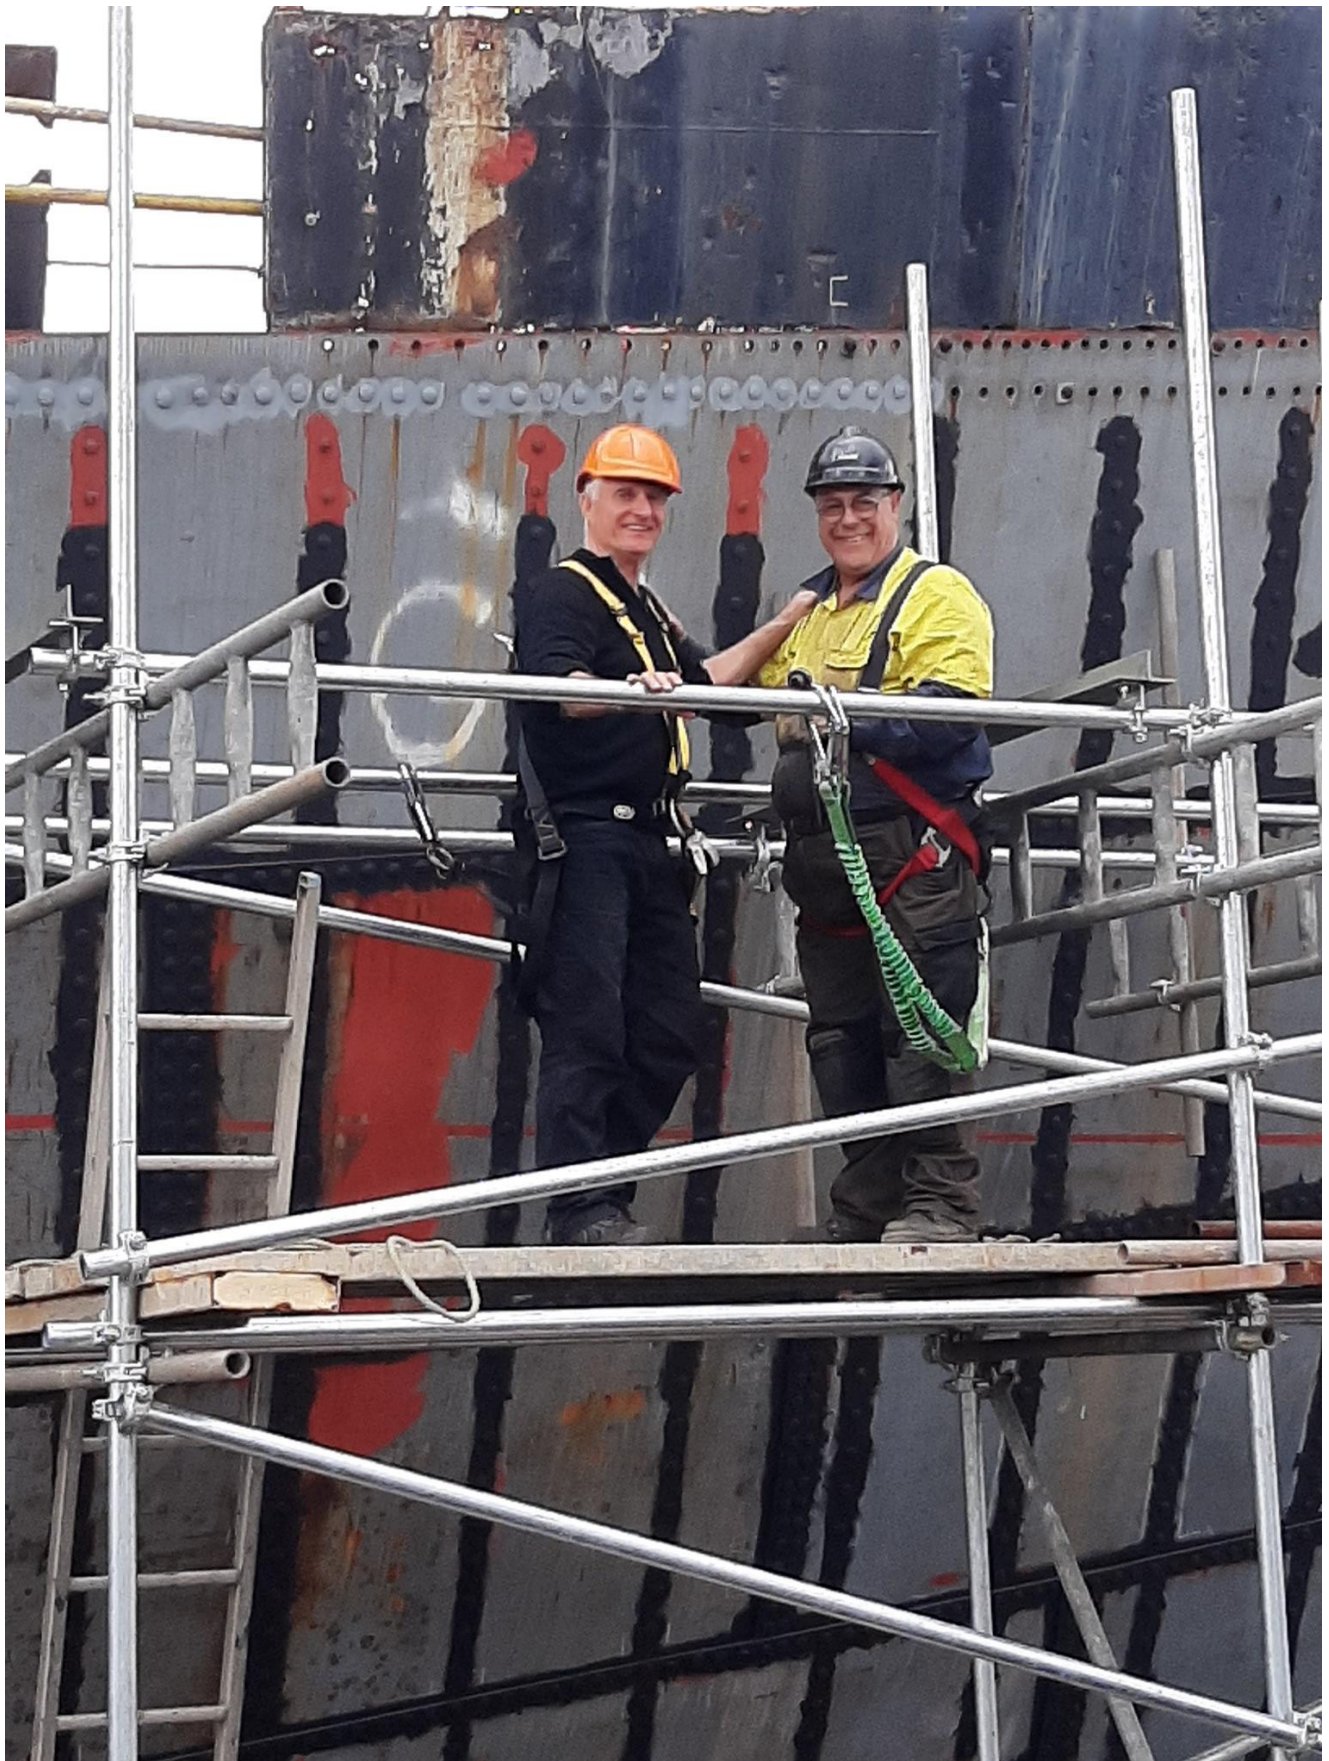
What a great pair, none other than Operations Manager, Tim Drinkwater & Chief Fabricator and Boilermaker Steve Stylianou. They are erecting scaffold at the bow of John Oxley to allow restoration of the Forecastle, the last remaining major portion of the ship to be restored. Note the Hard hats and Safety Harness. Picture courtesy Andy Munns.

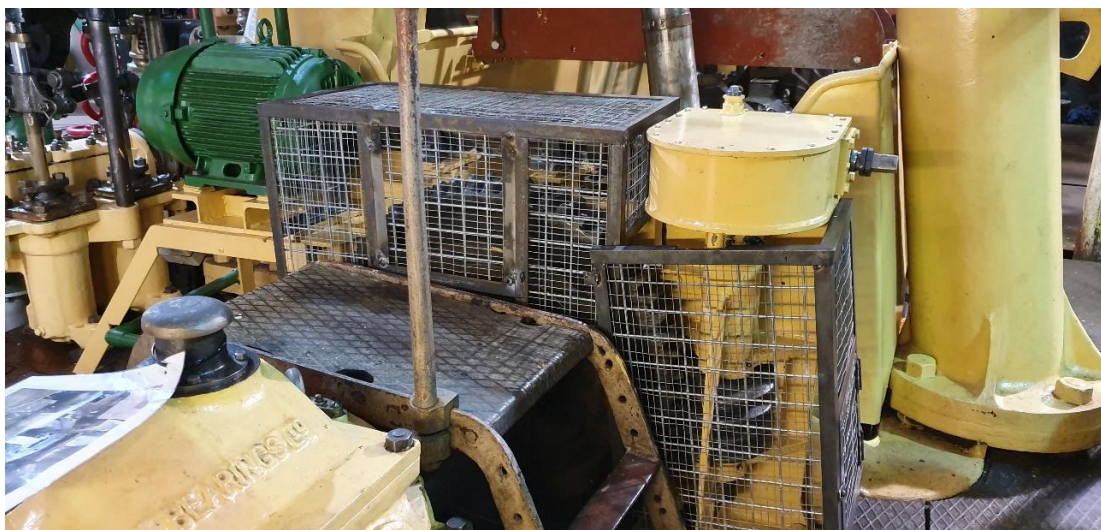
The top picture shows the main engine turning equipment consisting of an electric motor connected to a drive shaft to a gearbox in cream at the right.

As the ship will be on display often with the engine in a cold situation the engine is turned by the electric motor to display all the moving parts of a steam engine. The gear wheel is made in bronze to prevent overheating and smoking and is also housed in an oil bath.
