# PV JOHN OXLEY RESTORATION

## PROGRESS REPORT November - December 2018.

# JOHN OXLEY

## SHIP'S COMPASS

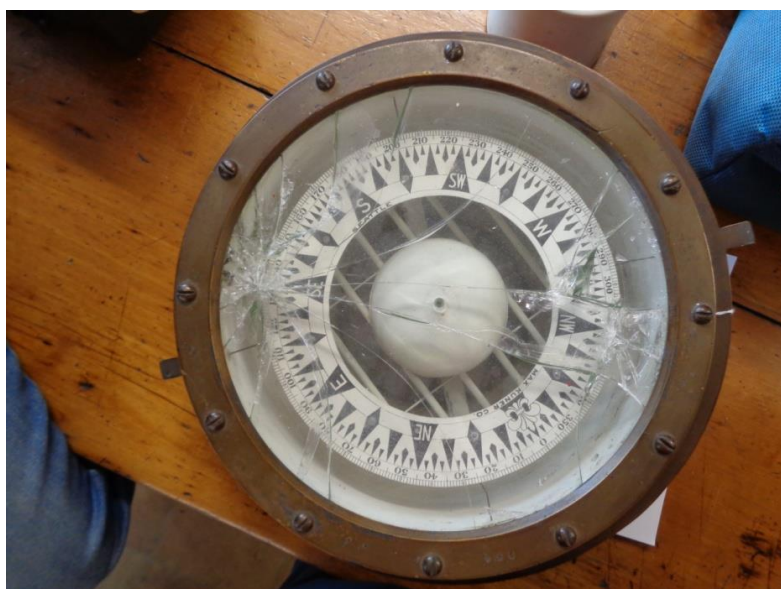
items in the depository at Wharf Seven and found only one that would possible suit but unfortunately the compass was in a pretty sad state – the top glass was shattered; the compass was bone dry and it looked rather beaten up. But it was the right type, age and size and most importantly, had the right mountings to suit our binnacle. There being no other suitable choice, it was destined to be our compass.

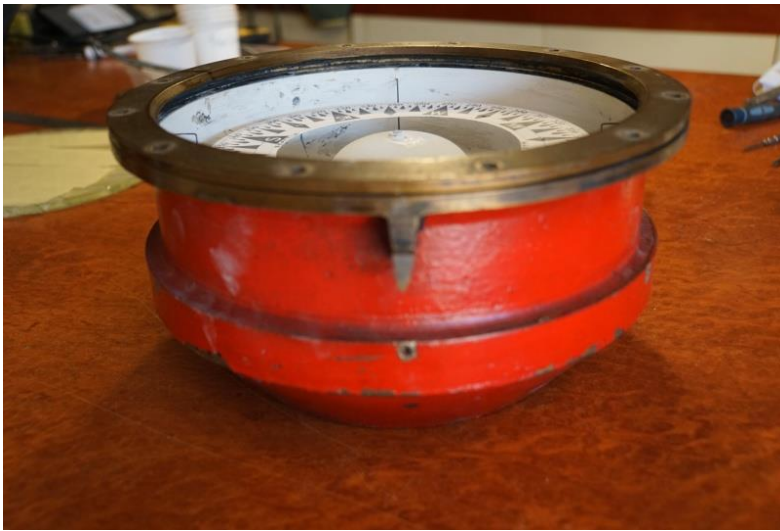
the binnacle and it dropped straight into the gimbal ring and only needed a new pair of gimbal keepers to keep it in place. One point down, heaps to go.

The compass project was started in April 2018 and over the next several months, between other jobs, family commitments and trips, the compass was dismantled and refurbished. New top glass was cut. The interior paint was powdery and rubbed off with a finger so this was replaced by epoxy enamel, the compass card getting the same treatment. (but very gently).

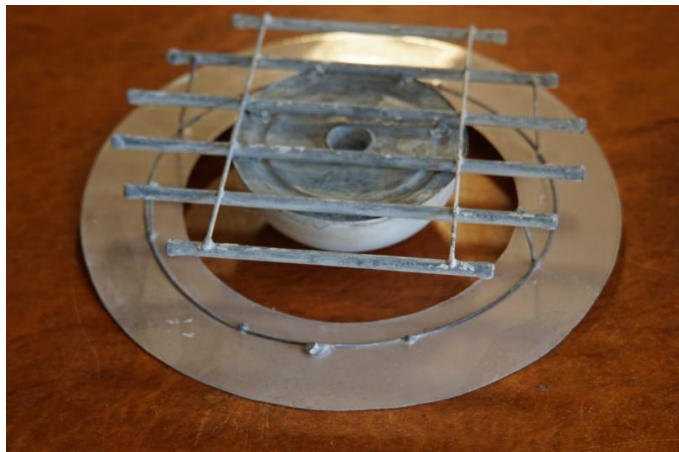
The compass card consisted of an aluminium frame containing the rod magnets and a float, attached to a mica disc on which was glued a paper compass rose.

Removing the dusty paint residue from the paper rose was a delicate task as I did not want to replace the original rose. The paint also just rubbed off the metalwork. The mica had delaminated in a few places and this was fixed using cyanoacrylate adhesive (better known as Super Glue). The pictures below are before it was repainted. I did consider touching up the printing on the rose to make the sector markers blacker but was not sure how the ink would react with the compass fluid so I left it alone.

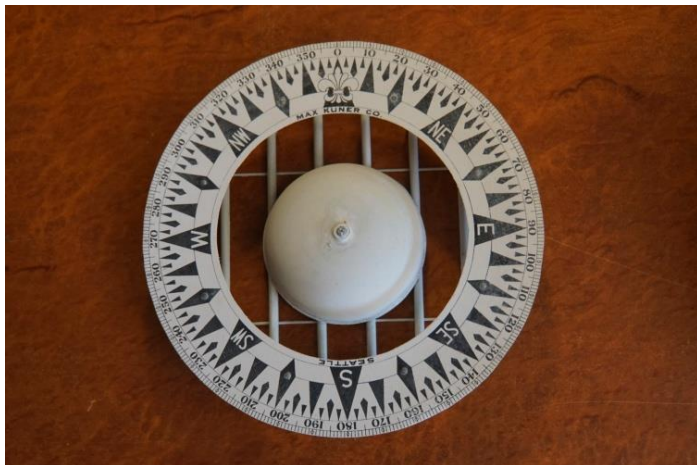
Having painted the compass card, I checked the jewel bearing for wear (negligible, despite its age) then carried out settling tests on the card. This consisted of using a magnet to pull the compass off its heading by 90 degrees and timing how long it took to settle back. It seemed to me to take too long so I increased the strength of the rod magnets by "stroking" each of them with a powerful magnet.

This greatly improved the settling time. (Doing this incorrectly could reverse the compass magnet, not the desired effect.)

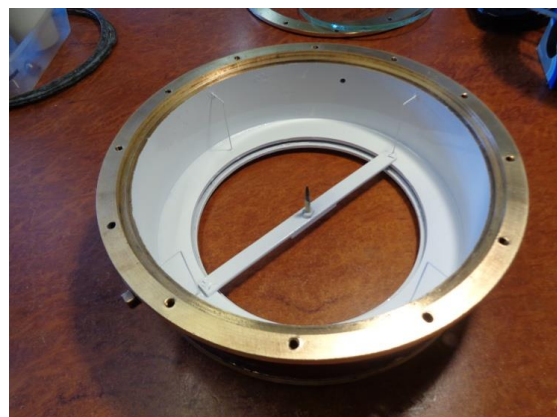
Having spray-painted the interior of the compass I then had to carefully scrape the new paint off the quadrant marker wires as they tended to disappear into the white background. You can just see them in

the picture.

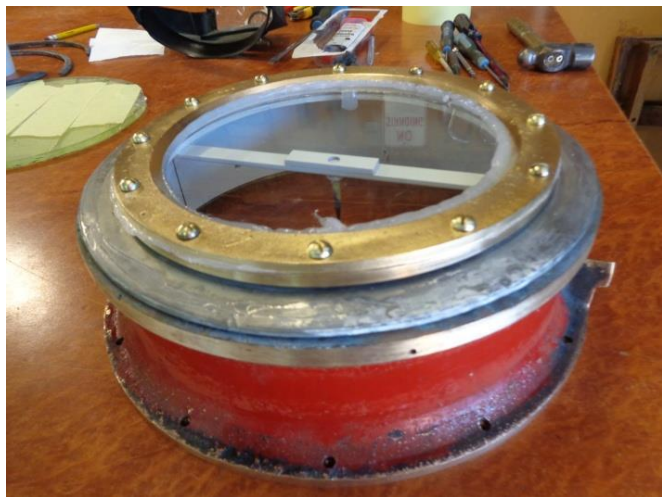
Both top *and* bottom glass had to be replaced; the top as it was smashed and the bottom because I cracked it after it was refitted and the cast brass ring was putting pressure on one point. The old leather seals for the glass were replaced by silicon sealant which produced an excellent seal, so good that it was a real pain to remove after I cracked the bottom glass. A new piece was cut and a fibre gasket added to the assembly to give some clearance of the cast ring from the glass, the second time around. You can see the sealant squeezing out around the bottom glass. I had to use a different approach when fitting the top glass as there was then no way to clean off any sealant inside the compass after it is sealed.

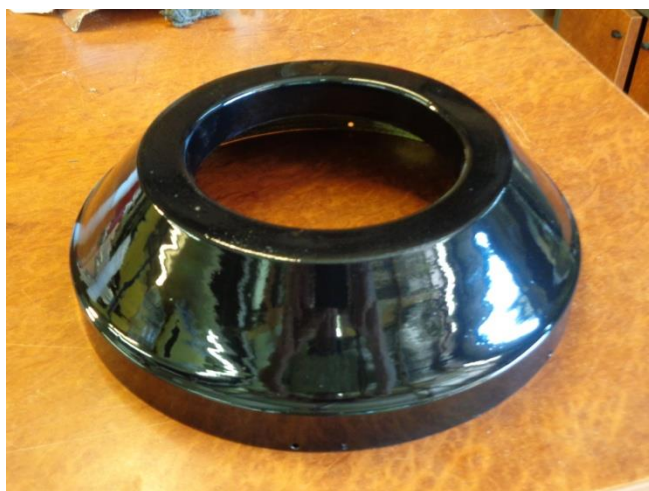
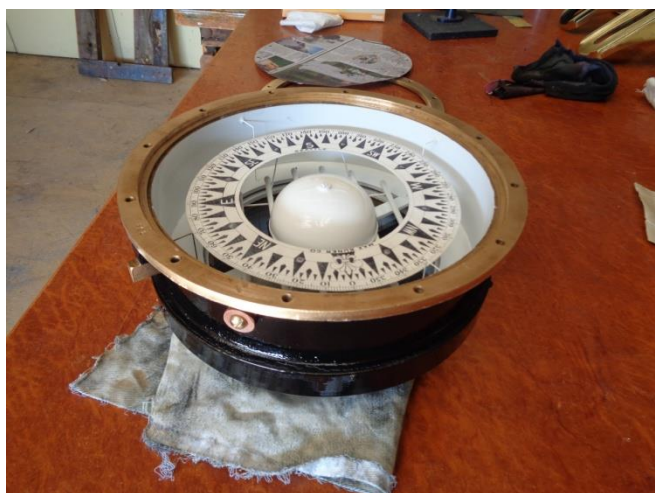
The exterior was given a coat of epoxy enamel with some surfaces left clear for buffing.

In case you are wondering, the compass has top and bottom glass as it is illuminated from a light box underneath.

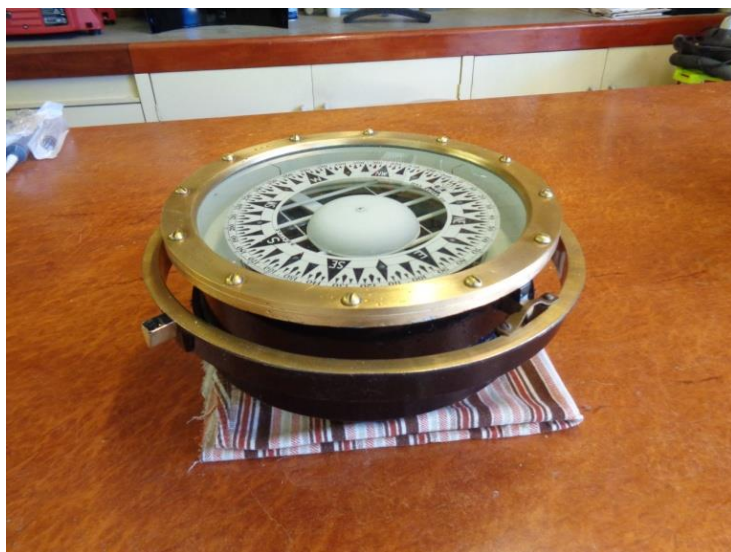
To fill the compass, there is a screw hole on the side which needed a syringe to transfer the fluid. A slow process and not without a certain amount of spillage. Filling was completed and the last bubble was extracted. The screw replaced and all was well. So, I thought. At that point, I had not refitted the weight casing (shiny black thing shown above). The compass was sitting on some sheets of newspaper and after an hour there was a stain under the compass. We have a leak (or two, or three!). The soldered seam joining the two halves of the bellows was the source of the leak(s). The suspected areas were marked and the fluid drained. The job was now to re-solder the seam with fresh solder using a heavy-duty electric soldering iron (no naked flame, thank you). Over the next several weeks, the leaks were fixed but there was always another one. Just the tiniest smudge of

fluid. I could not stop the problem and in desperation considered opening up the bellows and re-soldering it entirely. This is a big job and the last resort. Get it wrong and the compass is stuffed. However, a leaking compass is just not acceptable. Much discussion took place with several compass adjusters here and in the UK as well as our own people. Valid suggestions were made and I was even advised by one adjuster to “toss it away, not worth fixing.”

The final decision was made to coat the joint with epoxy. I used Araldite for the task and gave the joint a good coating. This didn't go off

and stayed tacky. Gave it a week and scraped it all off. Bought some more Araldite and tried again. This time it set hard (but with some flexibility). Problem solved, finally.

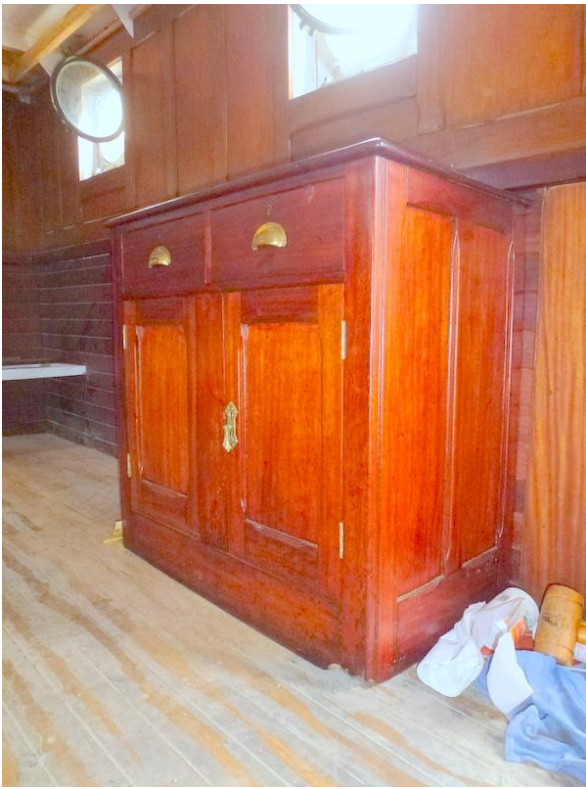
**Cabinetry by Alexandra McFarlane**
