PV JOHN OXLEY RESTORATION

PROGRESS REPORT August 2019.

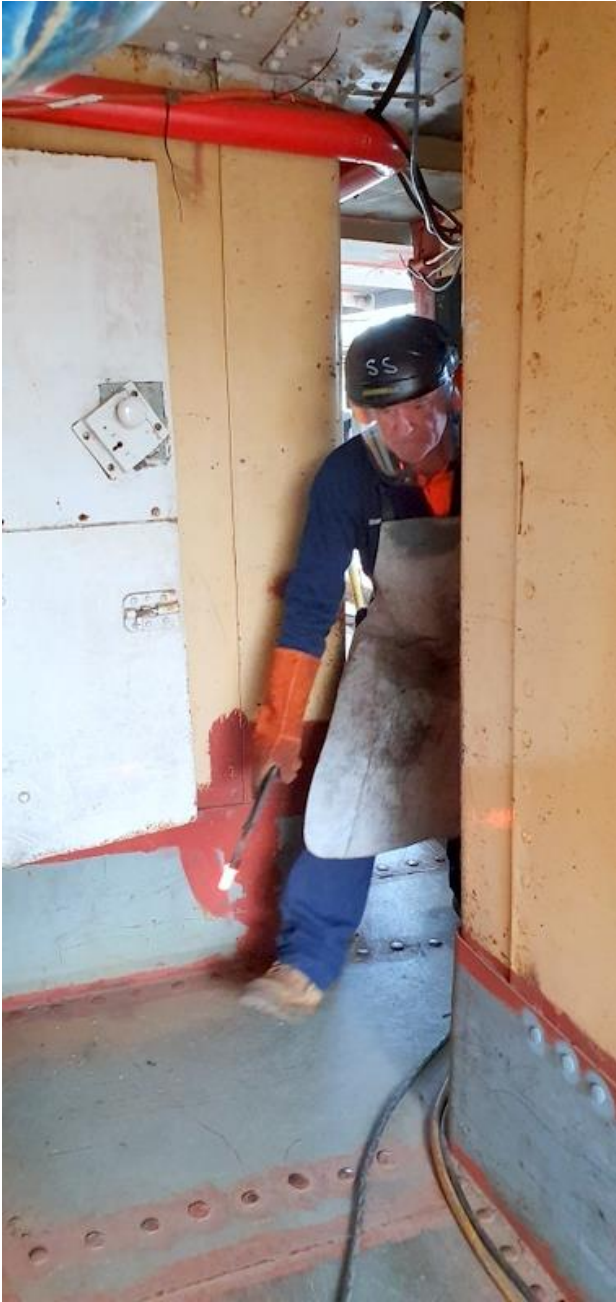
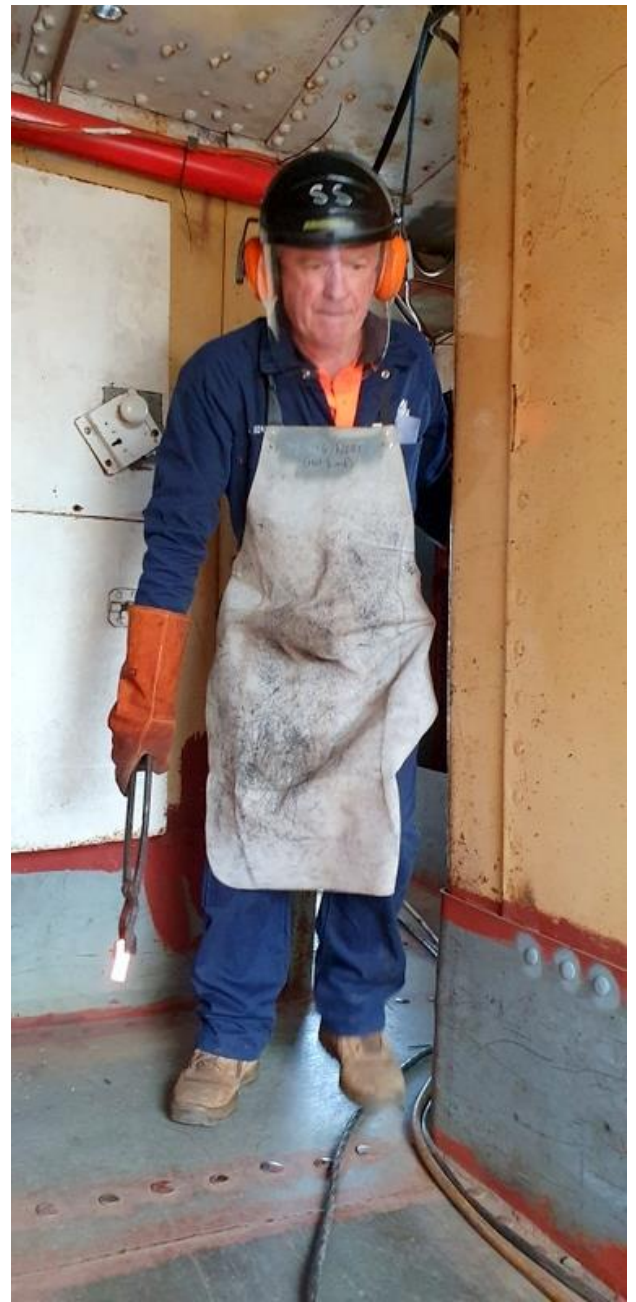
Bill Edwards with a look of grim determination as he walks swiftly from the rivet cooker to job site with gleaming hot rivet in his tongs.

Workshop: The Fabrication team, continues to fabricate steel sheet for the ship and the "Hot Riveting Team" has been currently riveting the Bullwarks and along the Mates Cabin on the Port side. A very popular job on these cold strong windy days for the rivet cookers and not so popular for Steve & Alex out in the wind on the Scissor Lift awaiting arrival of the hot rivets. The Starboard Side well deck Bullwarks are now almost complete.

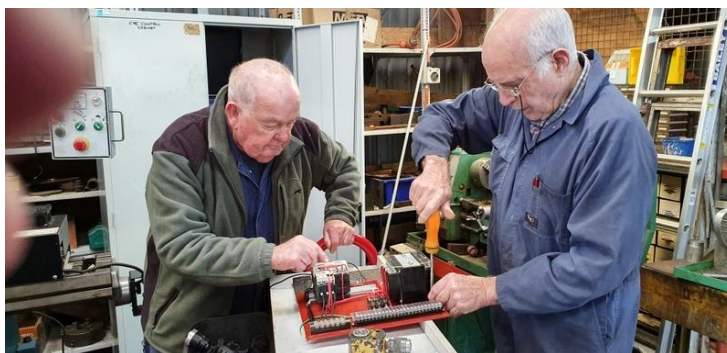
Electrical Team replacing circuitry on the drive of a donated milling machine.

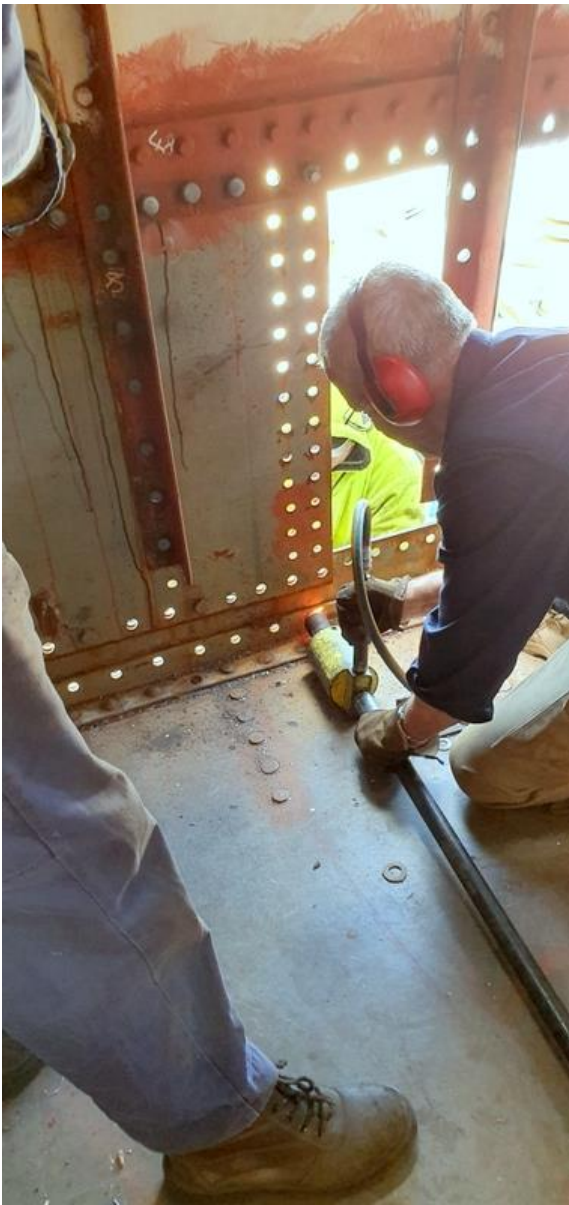
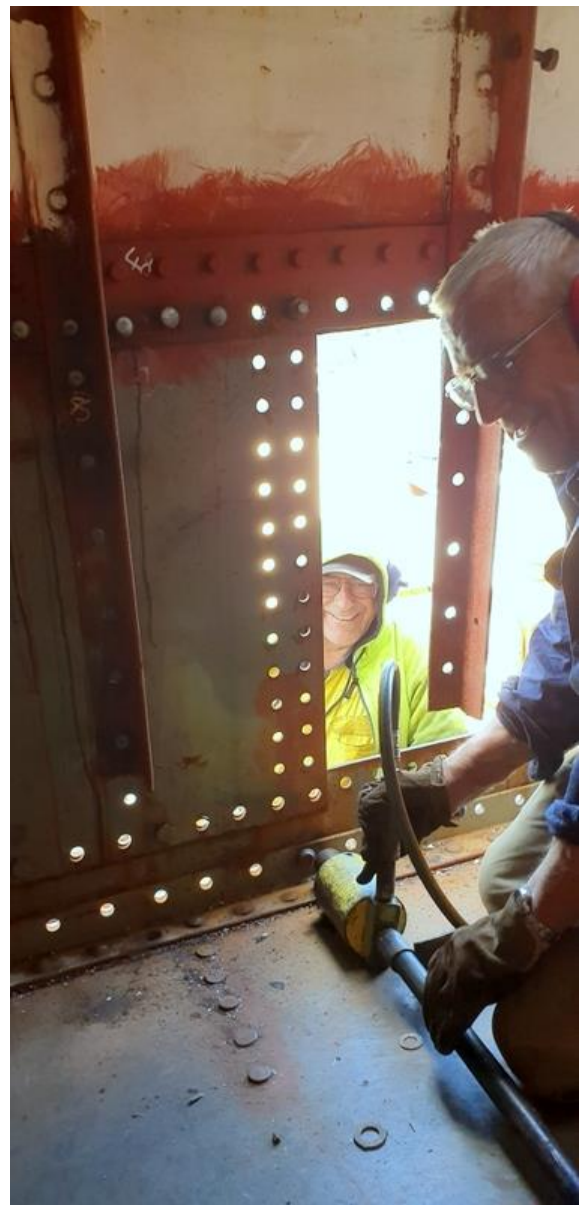
The hot rivet reached its destination in the Mates Cabin. Jack is holding the pneumatic dolly and Steve is that smiling guy outside on the Scissor Lift who was riveting with the gun.

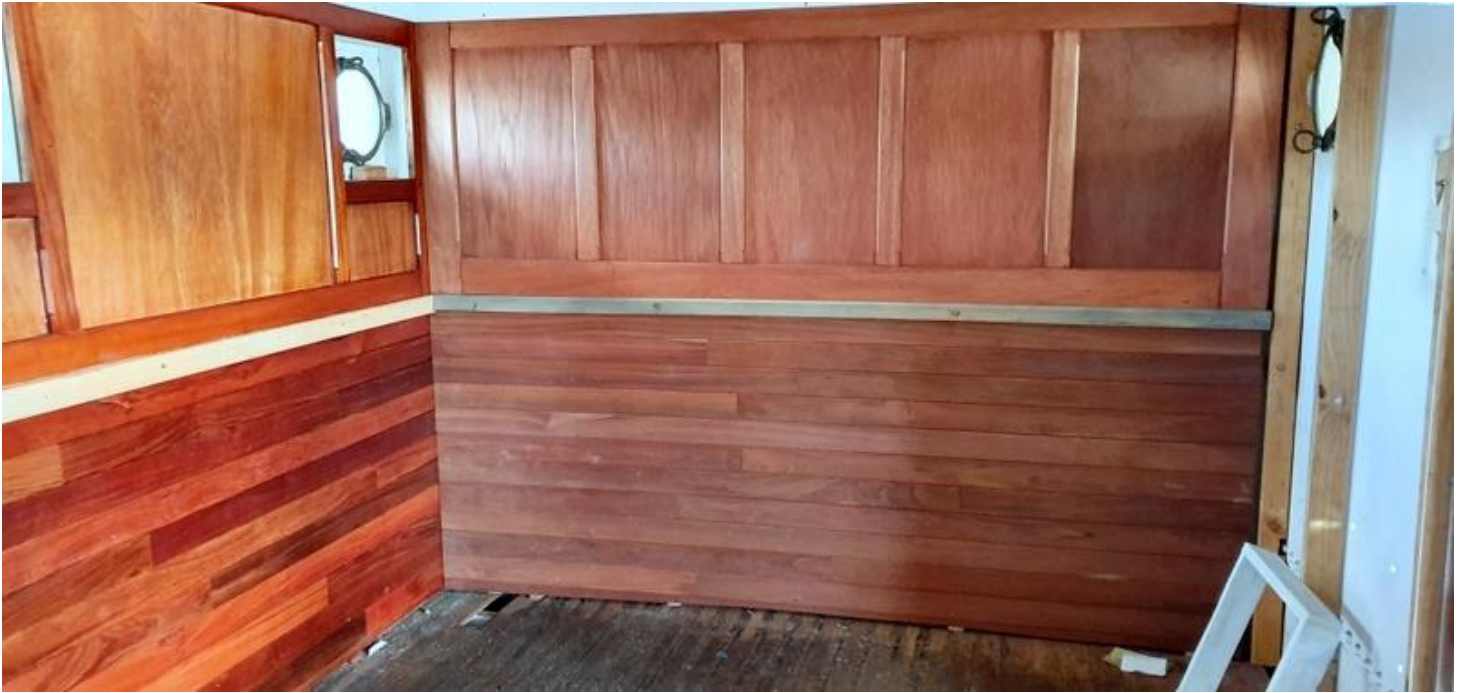
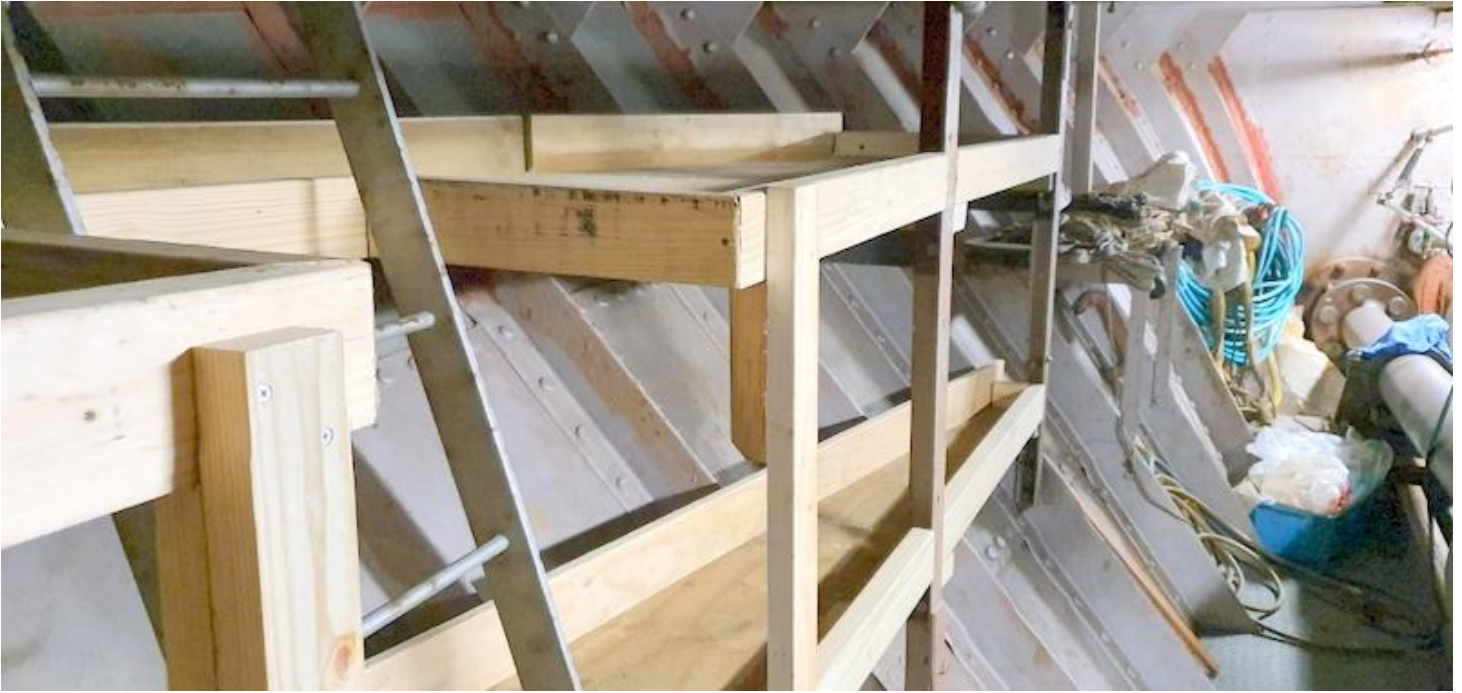
The Pilots Saloon beautiful refit thanks to Bob Ellis and company and below the Engineers shelving in the propeller tunnel installed by the same Team.

Pilots Saloon: The Bob Ellis team have almost completed the fit out of the saloon. Pictures show off this excellent work.

Engine Room: Minor work continues in the virtually completed engine room and pictures depict the work of the Carpentry Team's completion of the Engineers shelving in the Propeller Tunnel, now awaiting the painter extraordinaire Sandy Robertson to add some colour to them.

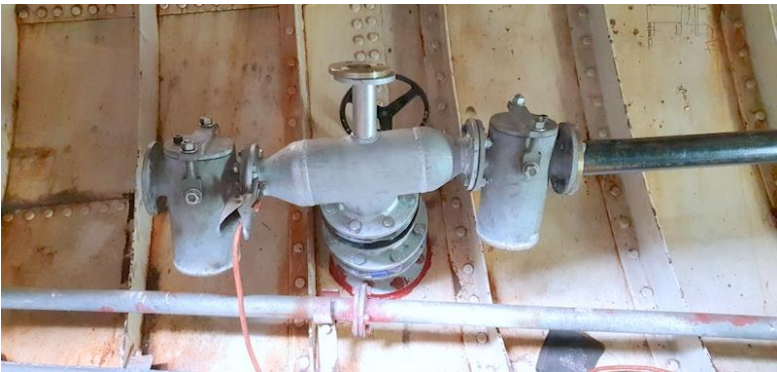
Main Hold seawater injection valve.

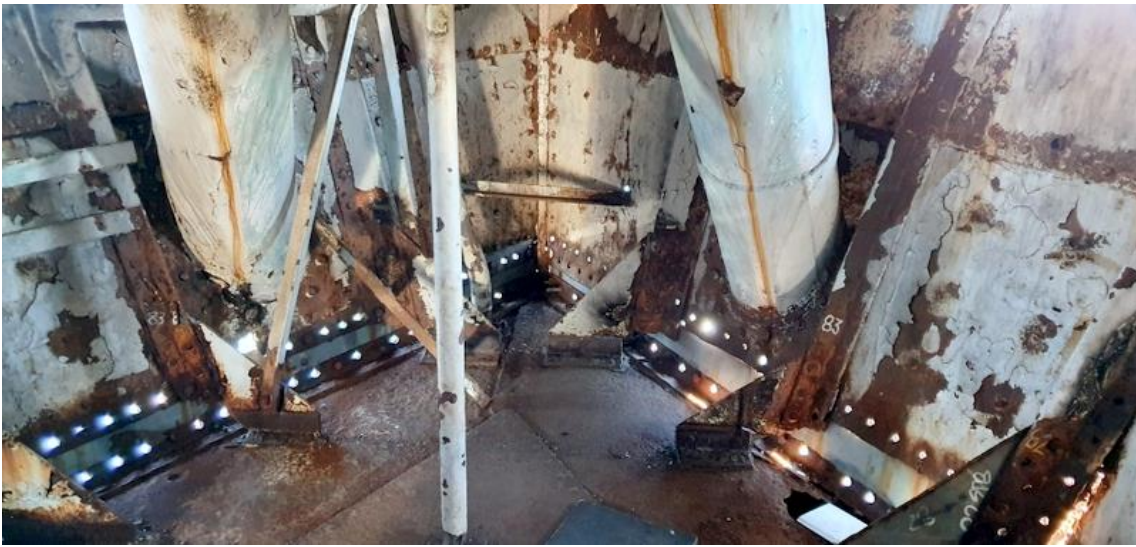
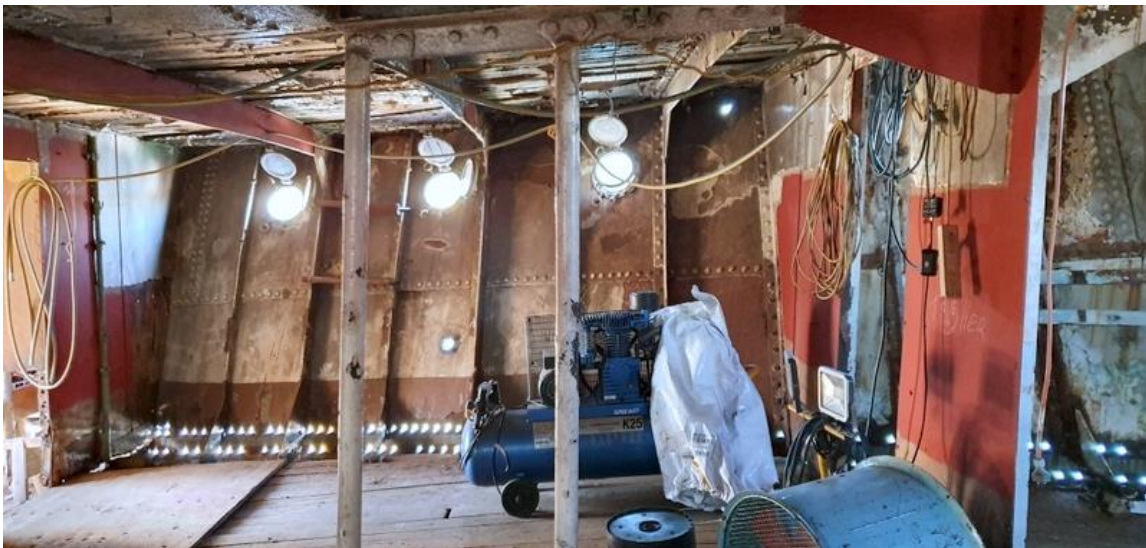
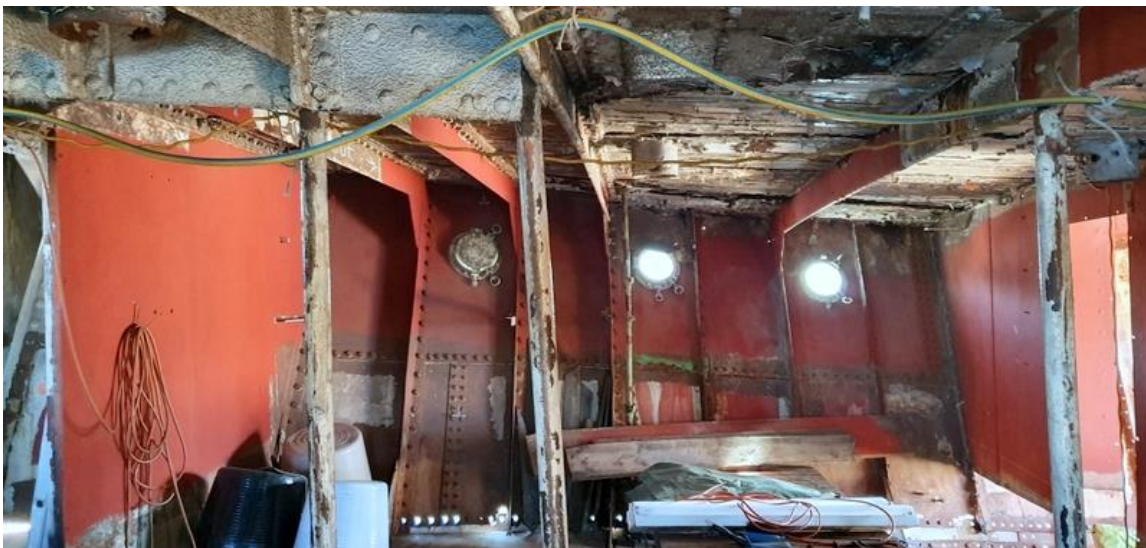
The Forecastle: Dismal pictures, readers have been accustomed to viewing pictures of restoration progress. The three pictures above show the internal sections of the stripped-out forecastle. The whole ship was looking like this which further indicates the huge progress made to date. Work in this area is starting and readers will be able to view improvements in future reports.
